Tucannon River LWD Restoration Project Site Assessment

Project # 1832 (&1573)

Prepared for Washington State RCO Salmon Recovery Funding Board by Washington State Dept. of Fish and Wildlife Watershed Steward, David Karl

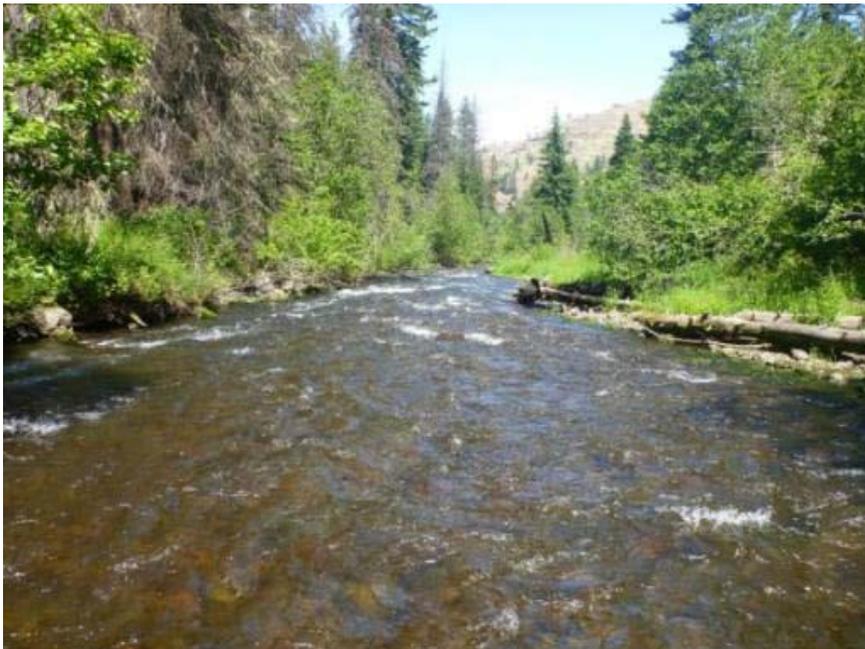
The river channel in reach A extends from Panjab Bridge downstream to the private property line upstream from Cow Camp Bridge. Reach A is characterized by a single thread with little habitat variability or complexity. This reach has several channel spanning rock and log weirs that both cause some of the problems with the channel morphology, but also provide much of the habitat variability that exists.

There is very little natural large wood (LWD) found throughout the reach and consequently the stream habitat complexity and pool frequency/quality is poor. The riparian is in fair to good condition in this reach with a mix of deciduous and conifers, dominated by conifers Doug Fir, Ponderosa Pine, and White Fir. The lack of natural LWD is also significant because Reach A was the reach least impacted by recent fires in the Tucannon Valley and has the best riparian conditions of all three reaches that were assessed. It suggests that both natural recruitment and large wood retention is limited in this reach.

Photo 1. Reach A – Straight, simple channel form; rare LWD on right bank. (Photo - Anchor QEA, 2011)

The floodplain connectivity throughout Reach A is fair; however, many side channels have been stranded by rock weirs, rootwad revetments, and other similar structures. Restoring LWD to this reach will increase floodplain connectivity and provide improved in-stream habitat complexity. However, additions of large wood with the specific intent of enhancing the existing rock and root wad structures is also needed, because these structures maintain a static point for the channel

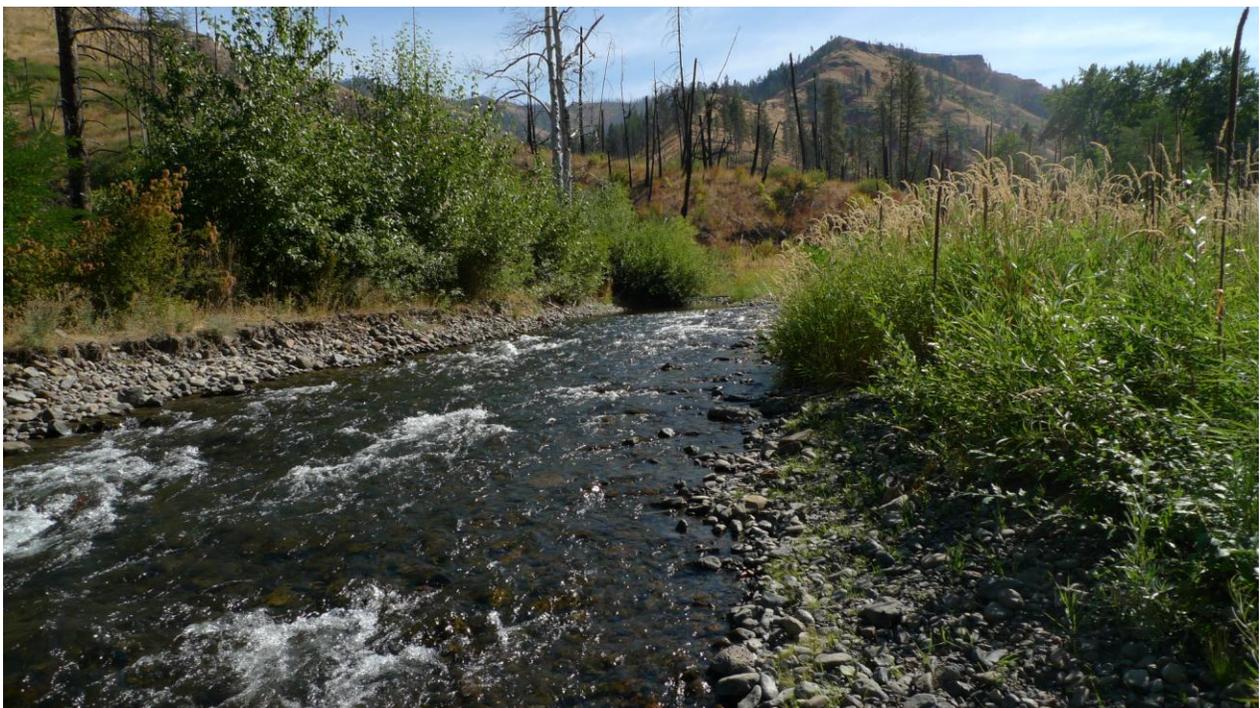
The majority of Reach B is incised with very little floodplain connectivity. Subsequently, off channel habitat is poor through large sections of the reach and instream habitat complexity is limited. Most instream habitat features are a result of large wood recruitment resulting from the School Fire or recent post-fire LWD restoration efforts conducted by WDFW and USFS.

The riparian in this reach is in early stages of recovery following the fire and provides limited shading and little potential LWD recruitment for many decades. The riparian is dominated by Ponderosa Pine that survived the fire and rebounding deciduous understory mostly Cottonwood and Alder. The addition of LWD structures designed to aggrade the channel and improve floodplain connection throughout this reach will benefit post fire riparian conditions and LWD recruitment in the future.

Photo 2. Reach B – Channel is highly confined, riparian has been degraded by recent fires.

Reach B immediately became a focal reach, and through the assessment became the clear priority among the three original reaches. Reach B has the poorest floodplain connection compared to the other reaches, and therefore has the most restoration potential for an LWD restoration project. Restoring LWD loading through the reach will increase the number of pools, improve stream habitat complexity, increase off channel habitat, and provide hydraulic connection with the floodplain that will improve conditions for the riparian areas adjacent to the stream. Additionally, the riparian in Reach B was heavily burned during the School Fire, limiting future LWD recruitment in the area. Downed trees on the floodplain currently cannot recruit to the highly confined channel, reconnecting the floodplain increases the potential for natural LWD recruitment. Also, because the fire had such a devastating impact on the riparian throughout the reach, it will be decades before natural LWD recruitment will occur in key areas of Reach B. Comparatively, reaches A & C both had better floodplain connection and riparian conditions. LWD restoration will benefit reaches A & C by increasing in-stream habitat complexity, improving floodplain conditions, and increasing off-channel habitat. Reaches A & C both border private landownership at the downstream end of the reach. Reach B is closer to the tree source and therefore more cost effective in regards to helicopter placement of the trees. The project for Reach B has a draft design and the design will be finalized in March 2012.

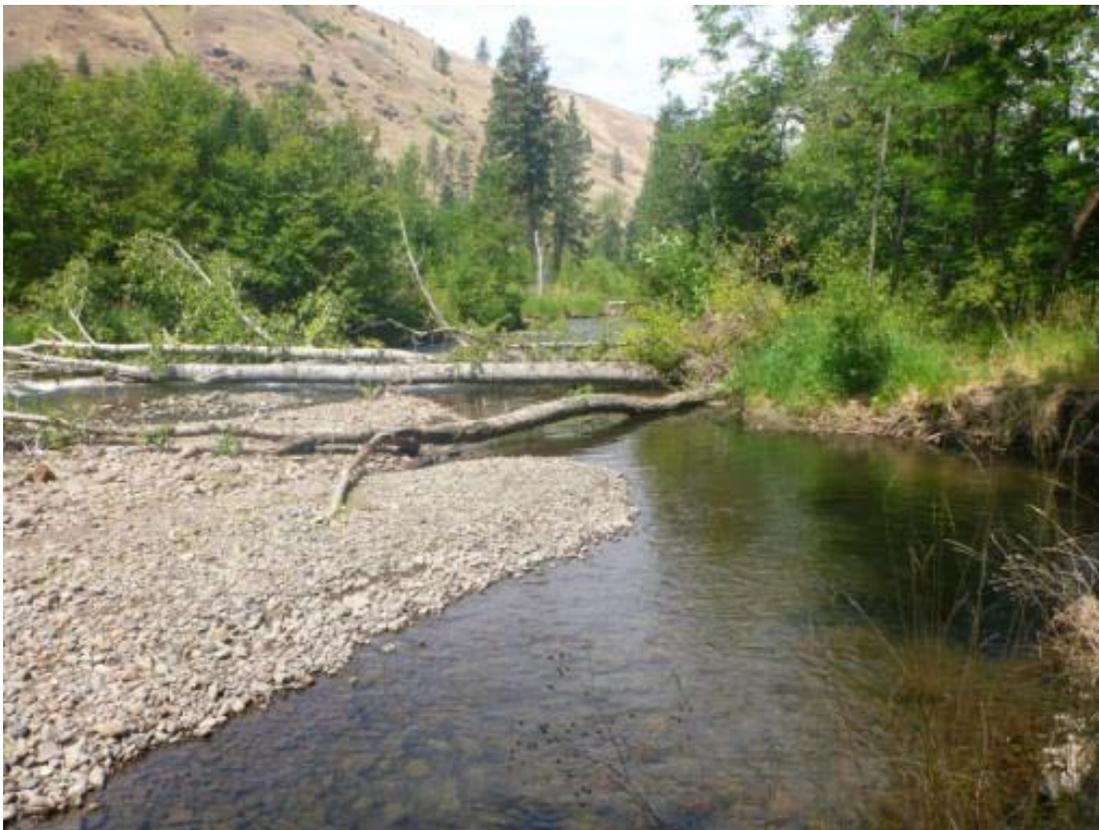
Reach C begins at the Spring Lake Bridge (RM 37.8) downstream to the private property line downstream from the Wooten WA Headquarters (RM 37.2). Reach C is also a single thread channel with limited stream habitat complexity. Most of the stream habitat features result from a few natural LWD jams found within the reach.

Floodplain connectivity in this reach is fair to good; however because of a lack of LWD structure there is still very limited off-channel habitat with only two small side channels identified. Restoration of LWD in this reach would provide more stream habitat complexity and increase river/floodplain interaction.

Photo 3. Channel with natural wood recruitment in Reach C (photo - Anchor QEA)
